# **PLAY AREA SAFETY INSPECTION REPORT (ANNUAL INSPECTION)**

**For Bucklesham Parish Council**

On 25<sup>th</sup> September 2023

Play Area, Playing Field, Levington Lane, Bucklesham

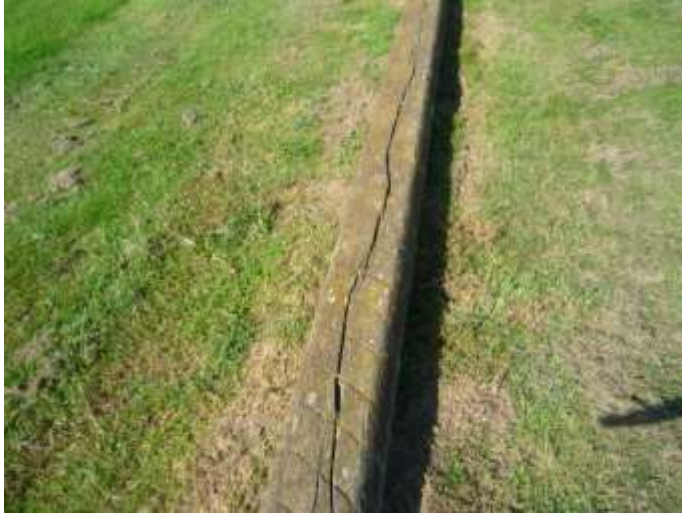
Log is static – Recommend repair to allow movement. Item can remain to be used as a static item and no hazard exists.

Recommend monitor cracks to timbers, smooth down any splinters when found, and ensure the cracks do not cross through fixing points of the structure and/or cause any instability. Replace any timber when 8mm and more gaps are found if in an area where a user grasps and climbs. (8mm and above fail the EN1176 finger entrapment probe when in an area that children grasp and climb.) Cracks let in water which may lead to rotting of timber (currently up to 3mm diameter cracks are found). Refer to manufacturers guarantee in regard to replacement criteria - Low risk.

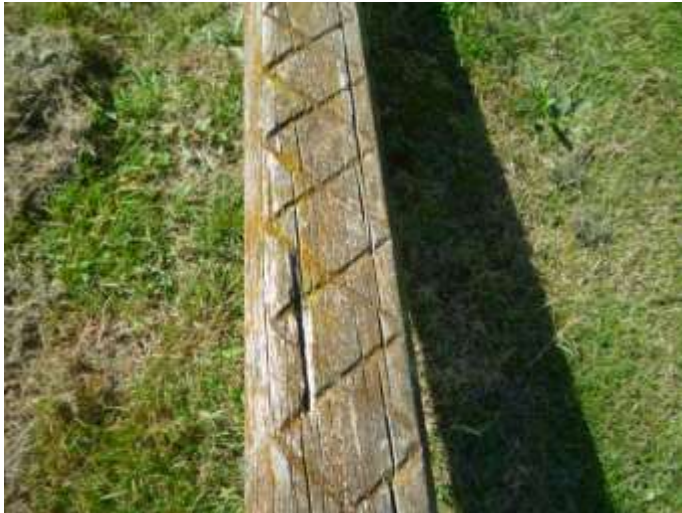
Slight rotting found on one beam – Recommend Monitor – Low risk.

Recommend monitor cracks to timbers, smooth down any splinters when found, and ensure the cracks do not cross through fixing points of the structure and/or cause any instability. Replace any timber when 8mm and more gaps are found if in an area where a user grasps and climbs. (8mm and above fail the EN1176 finger entrapment probe when in an area that children grasp and climb.) Cracks let in water which may lead to rotting of timber (currently up to 3mm diameter cracks are found). Refer to manufacturers guarantee in regard to replacement criteria - Low risk.

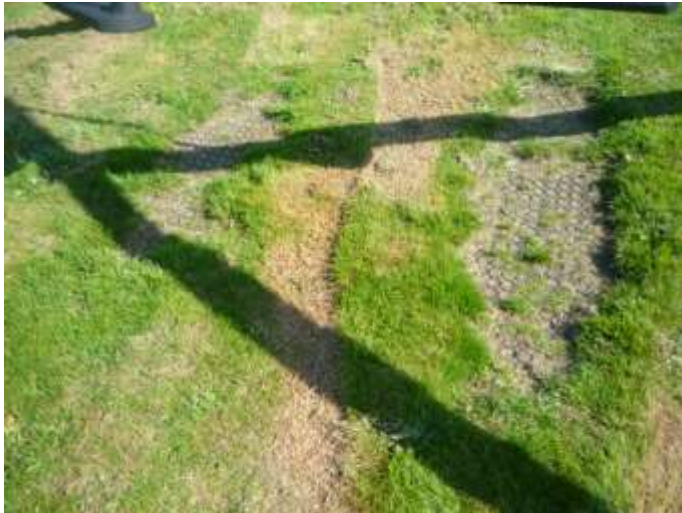
with a non-wearing type of safety surface such as Bonded Rubber Crumb or Wet Pour - Low risk.

N.B. If swings are in place over the worn surface, it is recommended to raise the height of the swing from surface to bottom of seat to 'industry recommended' 635mm, this may stop the users' feet dragging on the surface and wearing the grass.

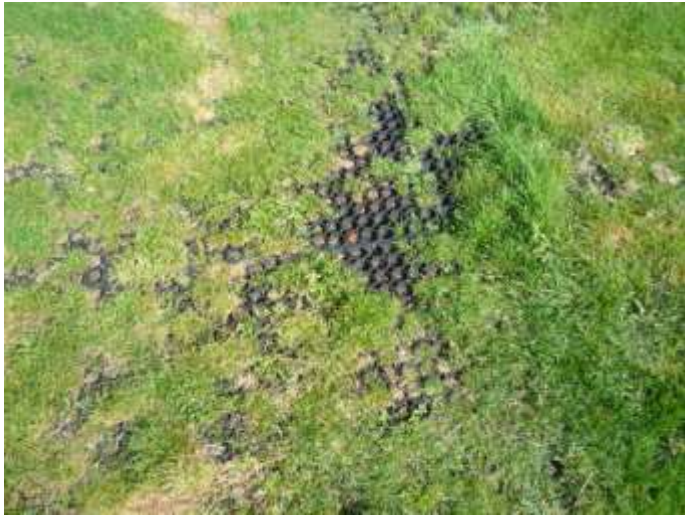
This type of safety surface should have grass present to provide adequate protection in user falls, as the grass roots absorb the impact of any falls. The surface therefore does not give the same protection as with grass and the risk of damage to users in falls is increased. In the first instance it is recommended to (when conditions allow) spread seed and soil mix over the worn areas - if this fails to eliminate surface wear, serious consideration should be given to replacing this surface with a non-wearing type of safety surface such as Bonded Rubber Crumb or Wet Pour - Low risk.

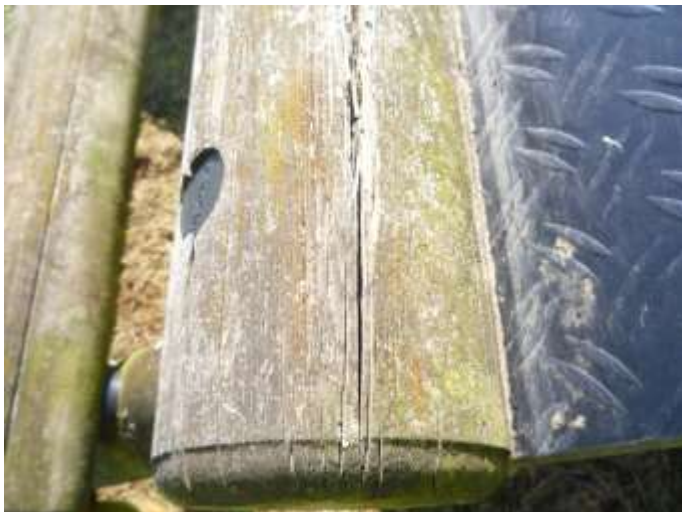
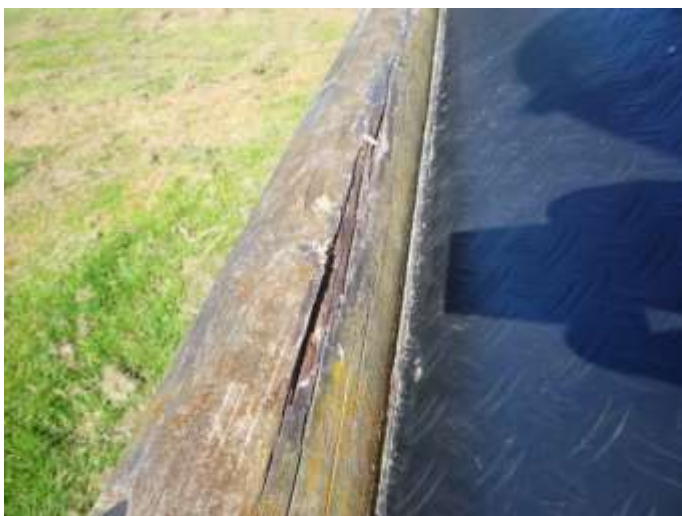
Rot is found in two beams – Recommend monitor and budget for replacement in the future - Low risk.

N.B. Considering the unknown age of the timbers, although no major visible rot was found above the surface level it is recommended that an underground inspection is carried out of the supports and if rot is found under the ground that this item is replaced.

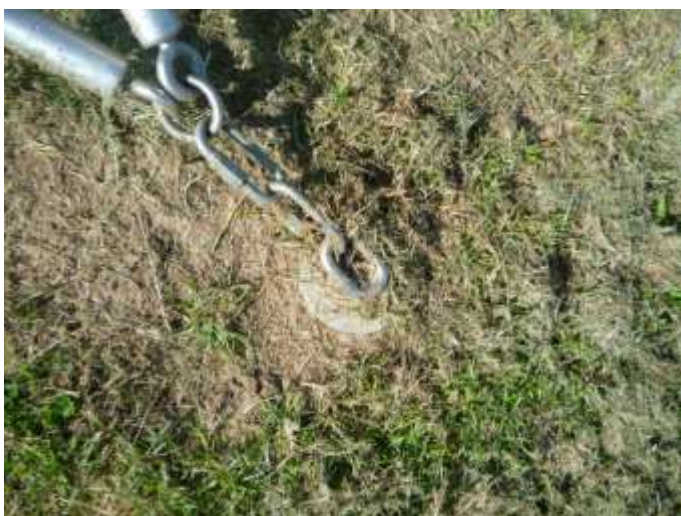
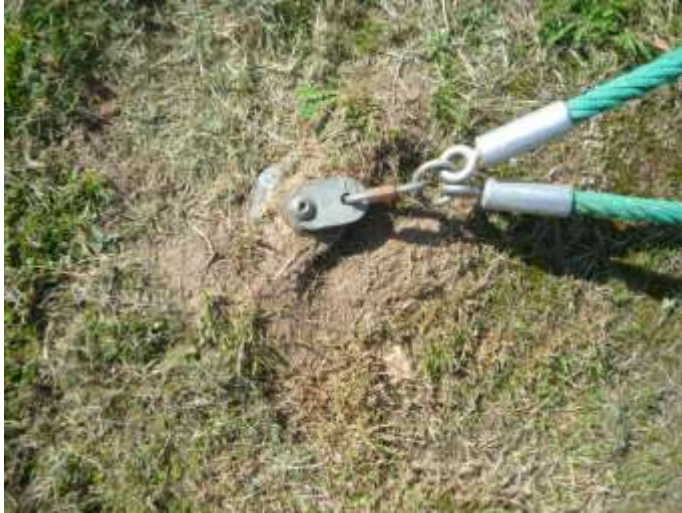
N.B. Strimming has exposed the chain – Recommend leave grass to grow?
